## Sonic Drive-In 3645 E. Fry Blvd., Sierra Vista, AZ

**FEATURE:** A dry delivery system (downspout directly to tank) from the west car covered parking area and a wet delivery system (downspout goes along the ground then up into the tank) from the east car covered parking system collected in a 3,000 gallon welded galvanized metal tank

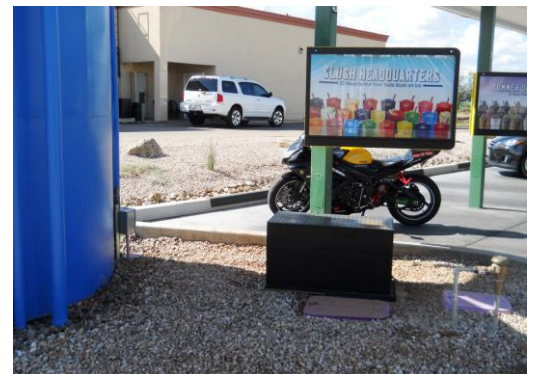
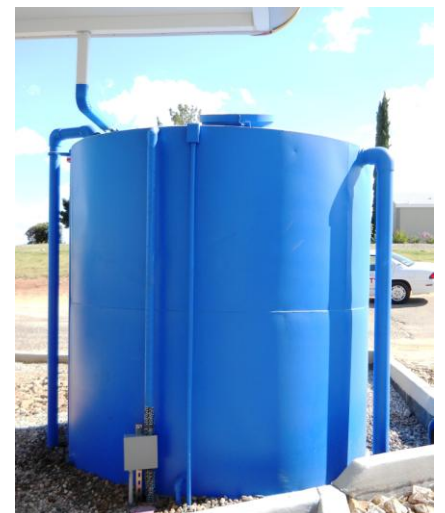
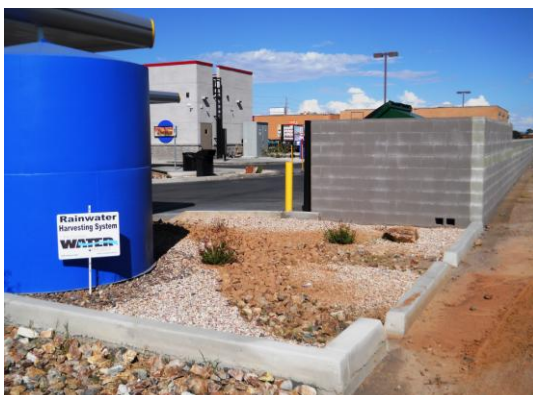
*First wash:* Yes. Basket strainer.

*Auto fill:* If rainwater is not sufficient, an auto fill using a motorized ball valve and a float switch inside the tank allows city water into the tank maintaining a minimum water level to supply irrigation water. There is an air-gap between the municipal water fill valve and the highest water level in the tank assures against cross-contamination of rainwater and municipal water.

*Overflow:* To the landscape.
